### B1. Introduction

### B3. Known Causes of Flooding (Assessing the Hazard)

B4. Flooding Vulnerability

# Township of Woodbridge Floodplain Management Plan

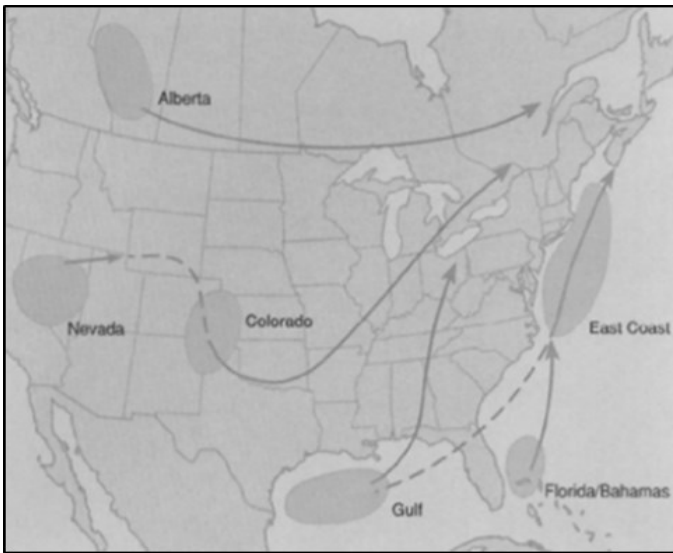
Figure 4: Typical paths of nor'easter

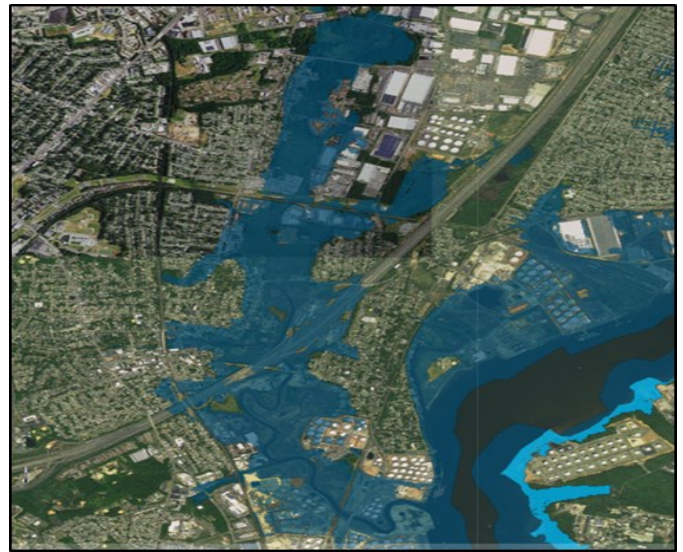
Figure 5: Approximate area of inundation in Woodbridge during Super Storm Sandy (Source: USGS Sandy Storm Sandy Tide Mapper)

As noted above, Woodbridge Township has a history of tidal flooding. The most extreme flooding occurred in 2012 during Super Storm Sandy, when the U.S. Geological Survey measured a High Water Mark (HWM) elevation of 12.5 feet NAVD88 at Station #NJMID07292, adjacent to the lower Woodbridge River. All low-lying areas adjacent to the Woodbridge River and Arthur Kill were inundated during this Storm, as illustrated in maps prepared by the U.S. Geological Service (Figure 5).

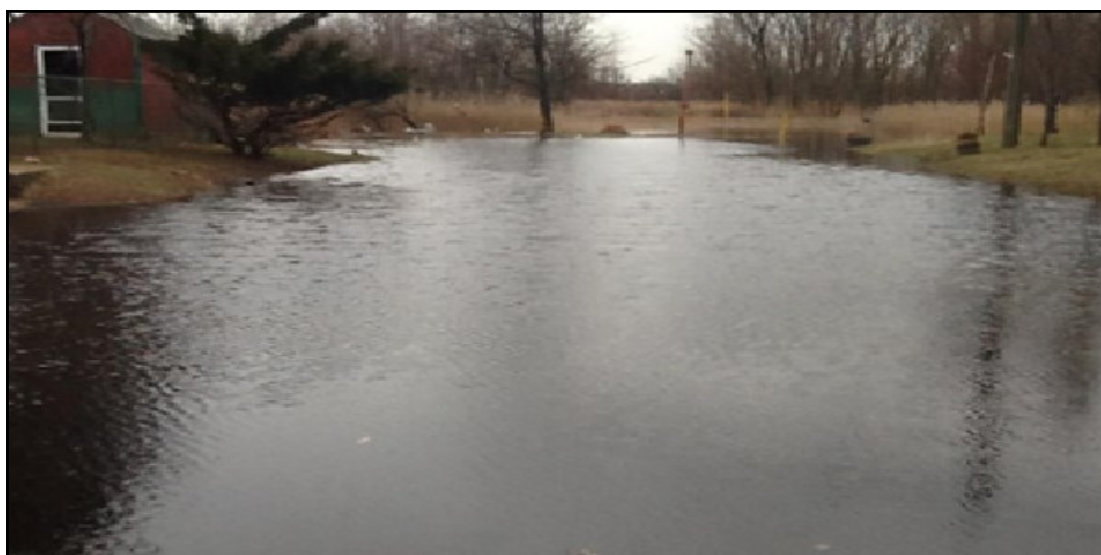
Figure 9: Heidelberg Ave. (CAN) Post-Super Storm Sandy

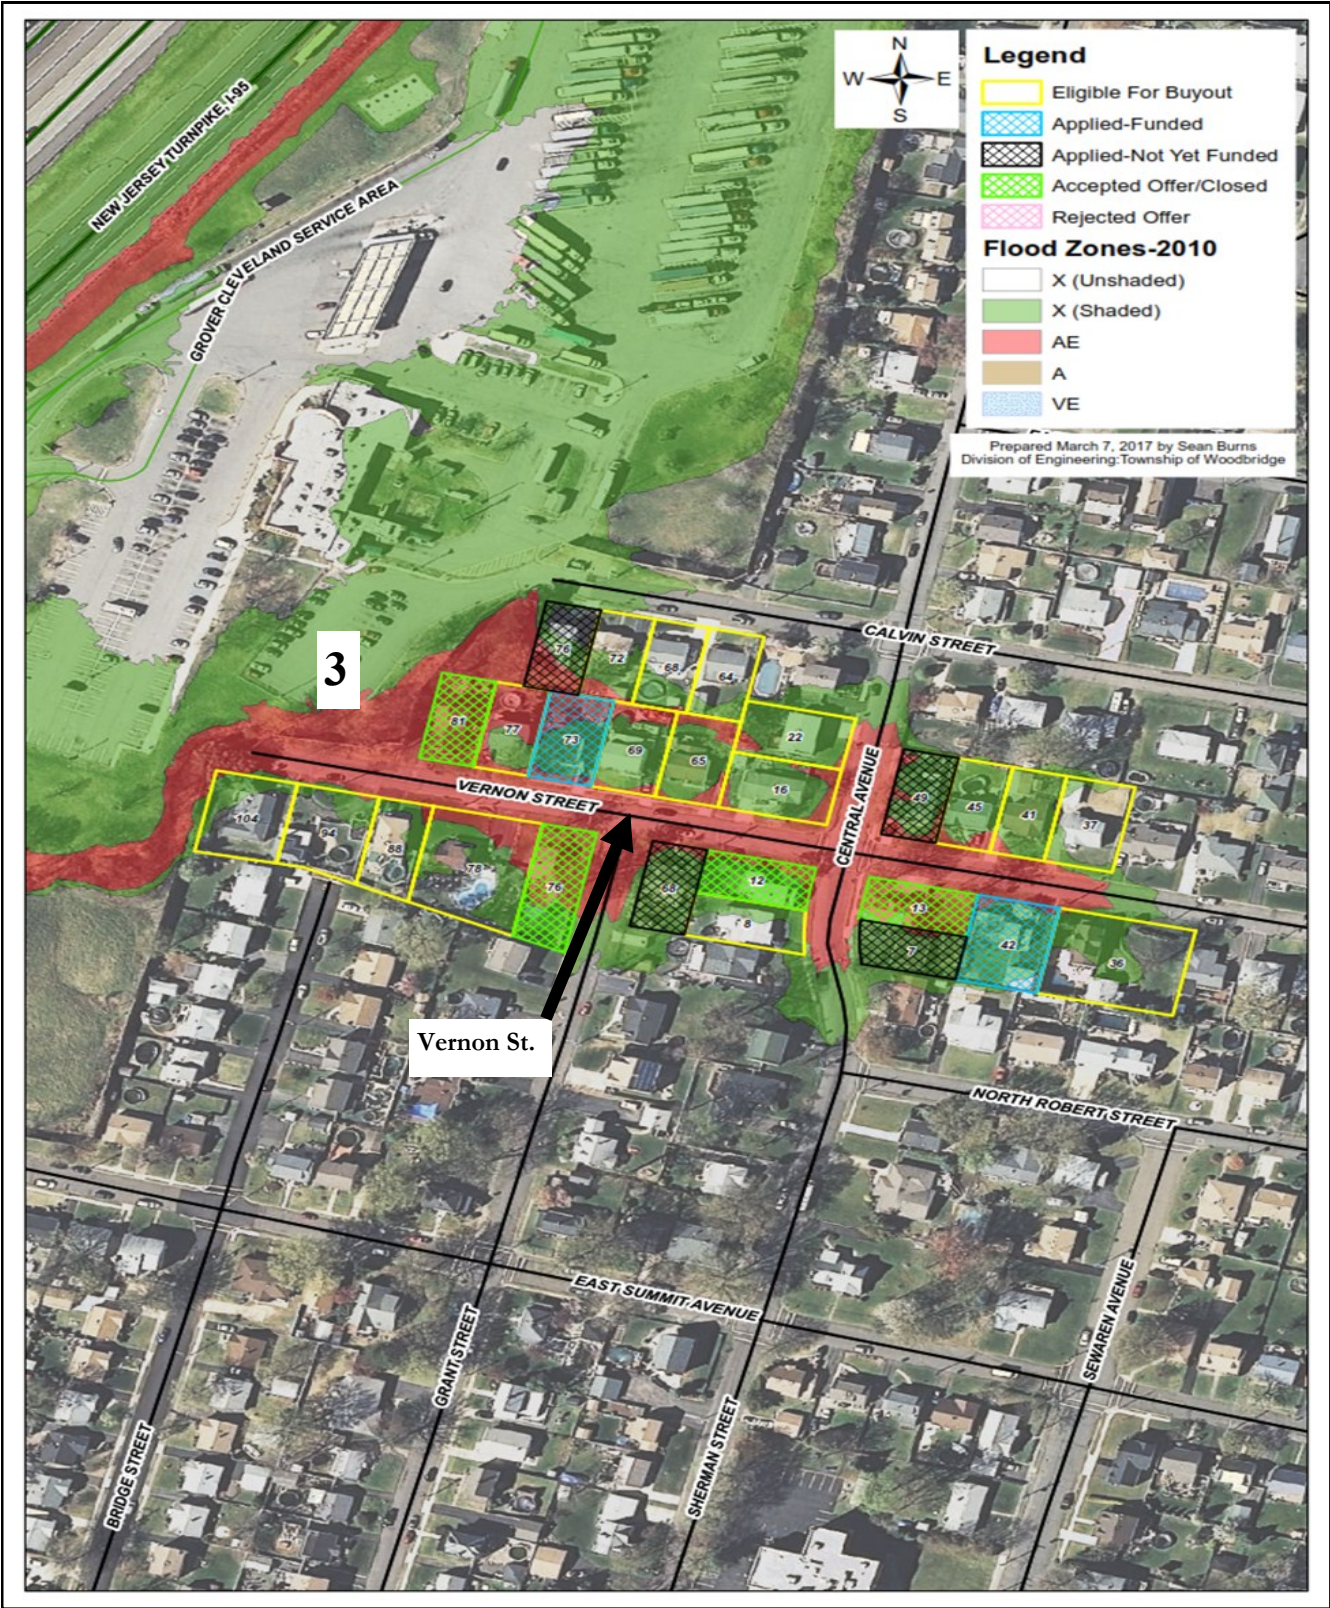
Figure 13: Status of Blue Acres Buyout program in Vernon Street Neighborhood (Area 3)

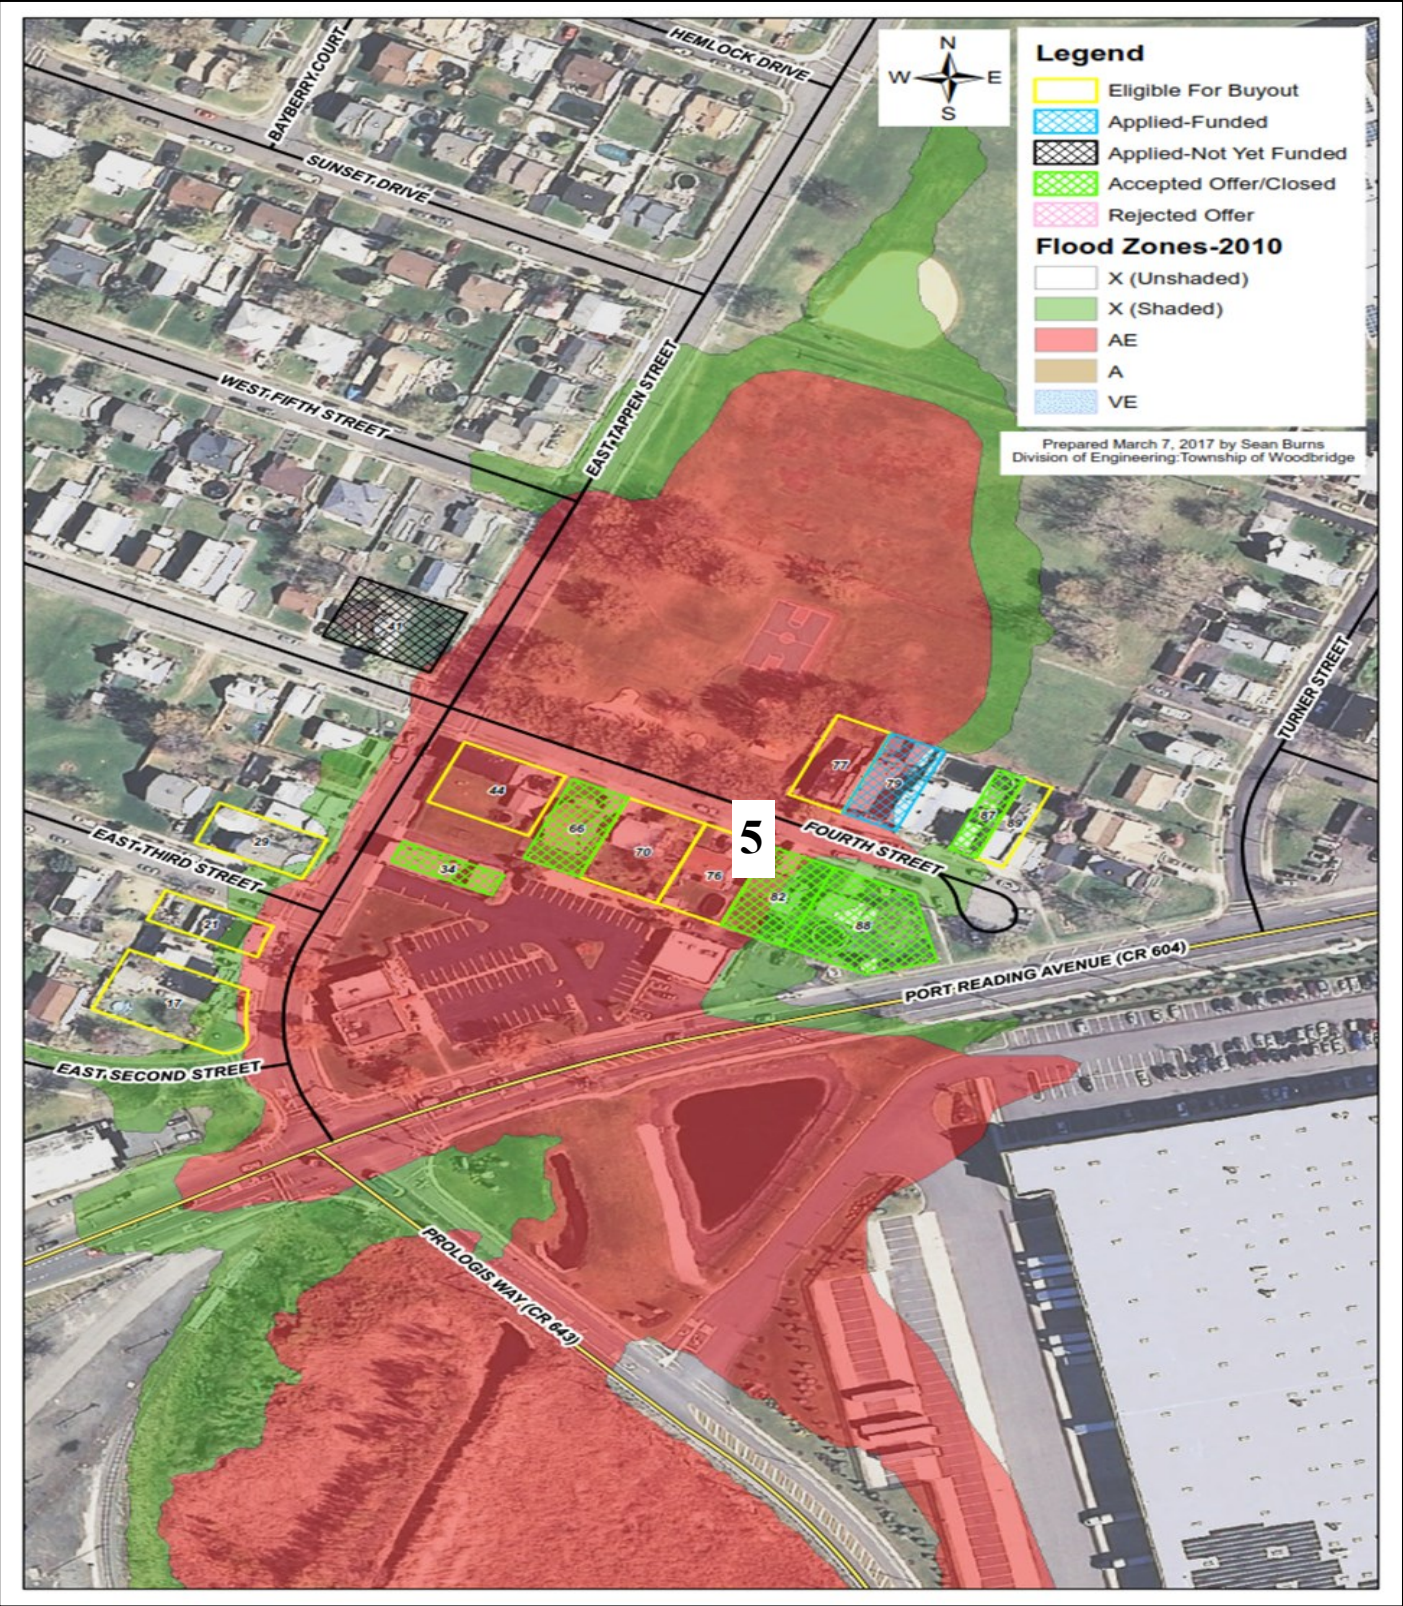
Figure 15: Status of Blue Acres Buyout program in Fourth Avenue Neighborhood (Area 5) In Port Reading section

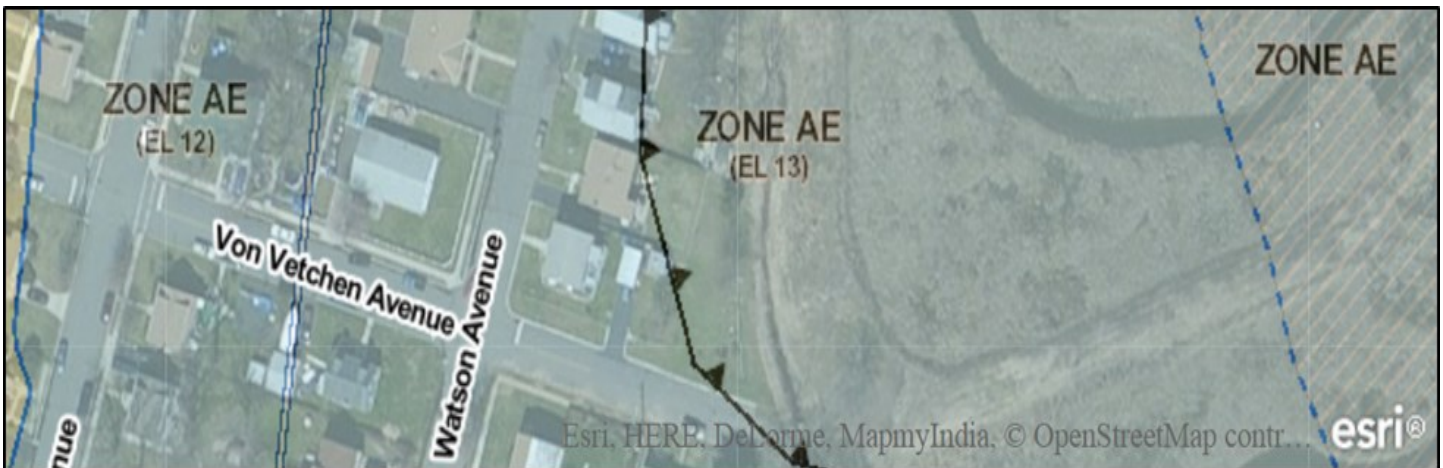
Figure 16: Coastal A Zone in 2014 PFIRM around Woodbridge River marsh crosses two homes in CAN

While storm surge is an important concern, wind wave impacts are generally not significant in Woodbridge Township due to the inland location of most insured structures. Thus, Coastal A Zones are limited. In the Woodbridge Proper section, Coastal A Zones in the PFIRMs are confined to adjacent tidal marsh areas near the Turnpike crossing of the Woodbridge River, and appear to encroach on only two structures (Figure 16). Since this PFIRM is being revised by FEMA, no further information is available at this time.

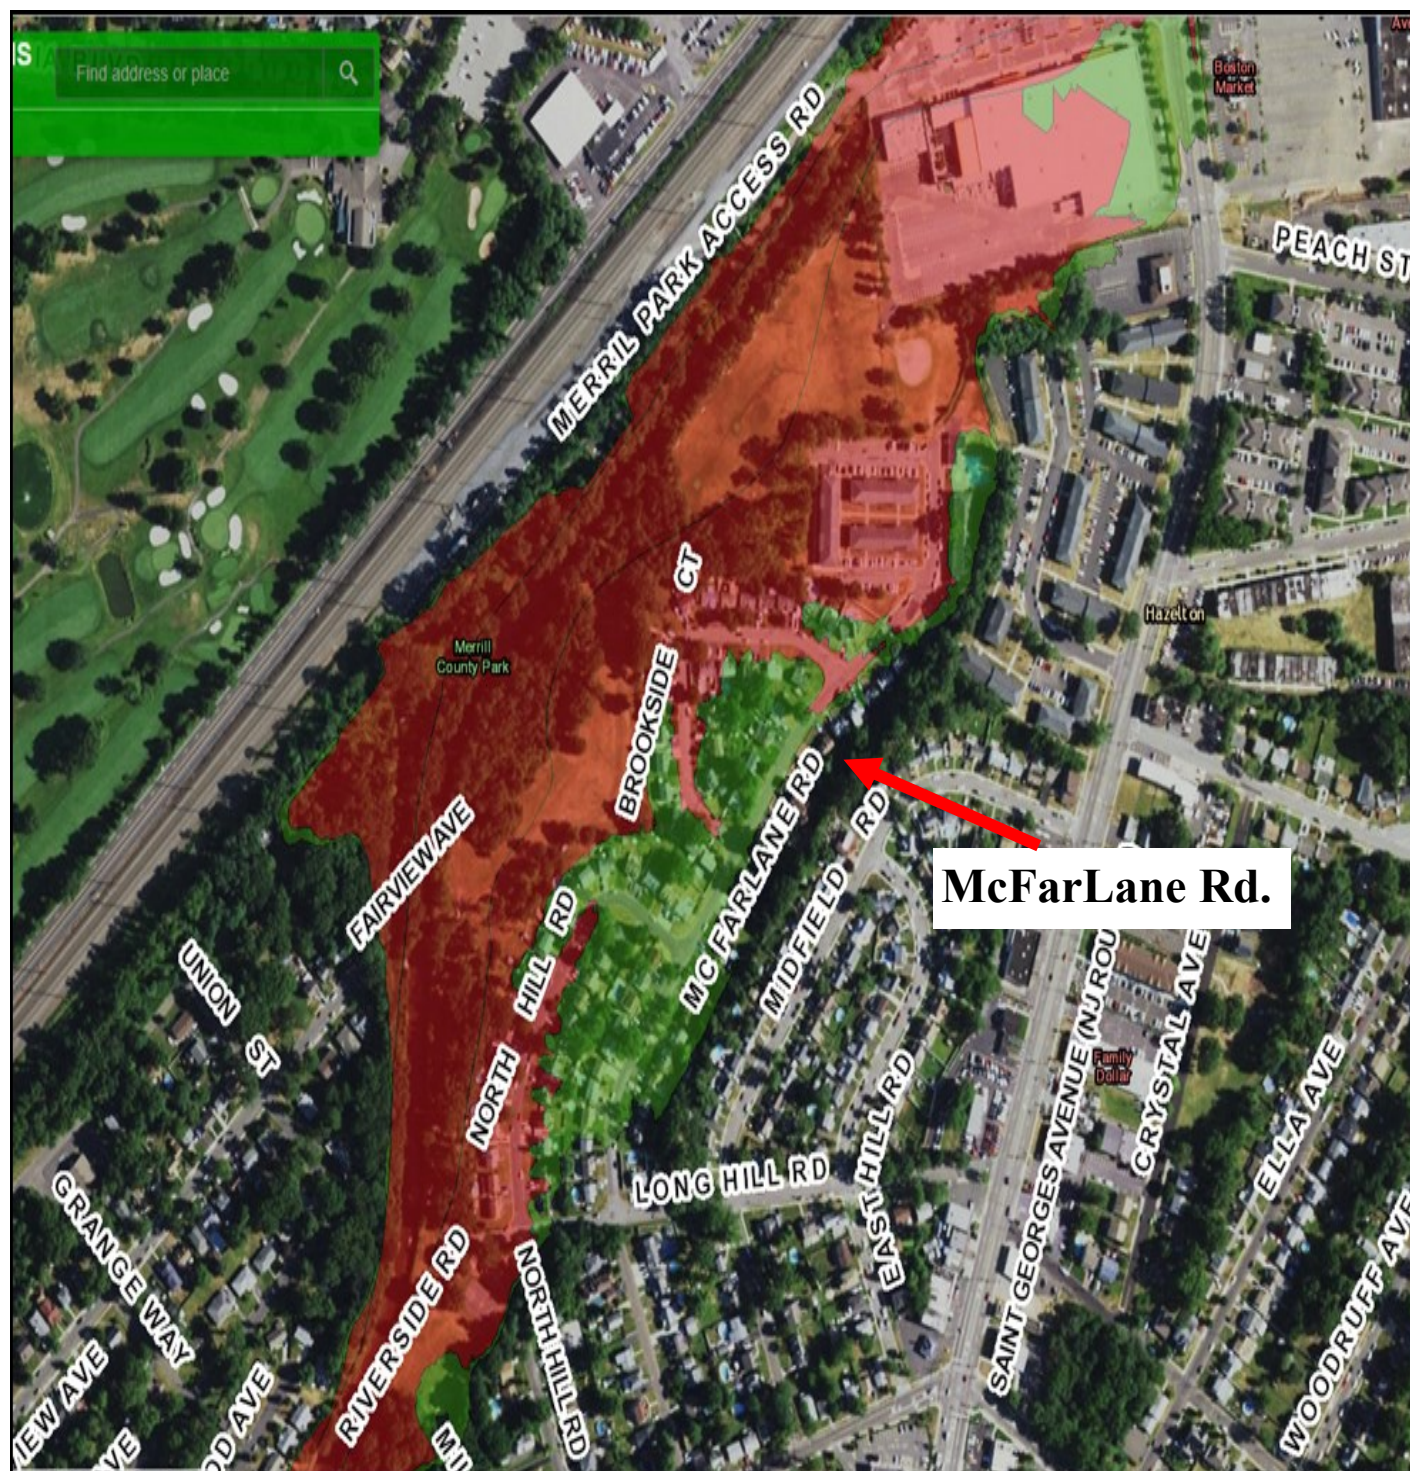
Figure 17: Neighborhood vulnerable to fluvial flooding along South Branch Raritan River near Route 35 crossing (2010 FIRM SFHA, as displayed on Woodbridge Township GIS)

Neighborhoods most vulnerable to *fluvial* flooding impacts are located mainly along the **South Branch Rahway River**, and **Pumpkin Patch Brook** within the western (and north western) sections of the Township (Figure 1B). Sub-urban development in Clark and Woodbridge Township has led to increased surface water run-off and long-standing cases of over-banking flooding along Pumpkin Patch Brook (Figure 19). In addition, Woodbridge, Rahway, Metuchen and Edison, are within the 11.6 square miles of the South Branch Rahway River Watershed. Reduced impervious cover in these areas has created a river with high flows, increased velocities, higher flood elevations and wider floodplains. The South Branch Rahway River, through Merrill Park, has experienced severe erosion and lost much aquatic/channel bank vegetation over the last two decades. Downstream flow constraints -- such as bridges, culverts or narrow channels -- cause backwater effects and contribute to upstream flooding. For example, during Hurricane Irene (August, 2011), the residents along McFarlane Road (Figure 17), Brookside Court and North Hill Road Figure 18) incurred significant flood damages. This flow conveyance problem is not easily solved, since there are always concerns that increasing the culvert/channel size at the Route 35 crossing may cause downstream impacts, and since land is unavailable for constructing adequate flood storage/detention basins. However, North Hill Road property owners have applied for Blue Acres Program buyouts, as illustrated in Figure 18.

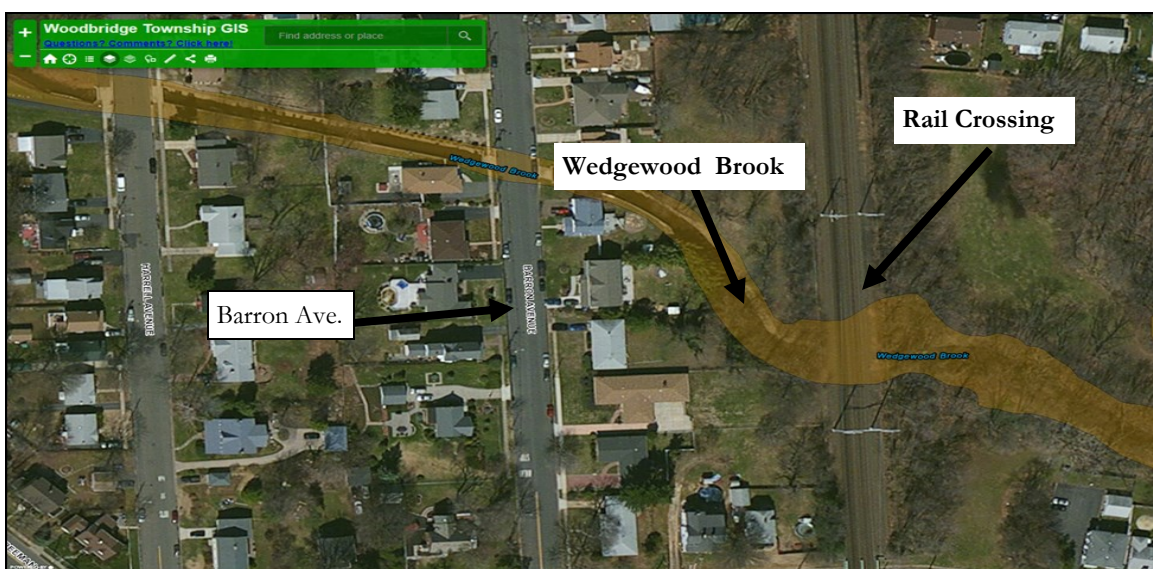
Figure 20: Neighborhood vulnerable to fluvial flooding along Wedgewood Brook near railroad crossing (2010 FIRM SFHA, as displayed on Woodbridge Township GIS)

Flooding south of Heards Brook occurs along S. Park Drive, which has a low point of approximately 22.5 feet, and may also flood during a 2-year storm event. Likewise, the high-flow, flashy nature of the non-tidal Wedgewood Brook (Figure 20) leads to flood damage during storm events. The main downstream flow constraint in Wedgewood Brook is the railroad crossing (Figure 20). This crossing consists of twin 48” culverts. Both the crossings upstream and downstream of this crossing are larger, and therefore have more capacity to carry flood flows. The upstream crossings at Barron Avenue (Figure 20) and Harrell Avenue crossings are 12 to 13 feet wide and 3 to 3.5 feet high; both larger than the Railroad Bridge culverts. During Hurricane Irene in late August of 2011, areas upstream of the Wedgewood Brook’s crossing at the Railroad Bridge were flooded, including the Barron Avenue neighborhood.

The low point in Barron Avenue (Figure 20), at the Wedgewood Brook crossing, has an elevation of approximately 16.6 feet. Upstream of the Barron Avenue crossing is Harrell Avenue, which has a low point of approximately 19.6 feet. Model analyses (Najarian Associates, 2013) indicate that the 100-year storm has potential to flood the area to a depth of over 9 feet. Structures as far upstream as Greco Lane also have the potential to be flooded during a major storm event. Approximately 42 residential structures could be affected by the 100-year storm event. The Najarian Associates analysis also revealed that the railroad culverts downstream of the Barron Avenue neighborhood provide a major backwater effect to areas upstream. Since the Railroad Bridge is acting as a berm and creating storage in the floodplain upstream, any increase in the rate of flow through the railroad culvert would, unfortunately, increase flood elevations downstream of the railroad crossing.

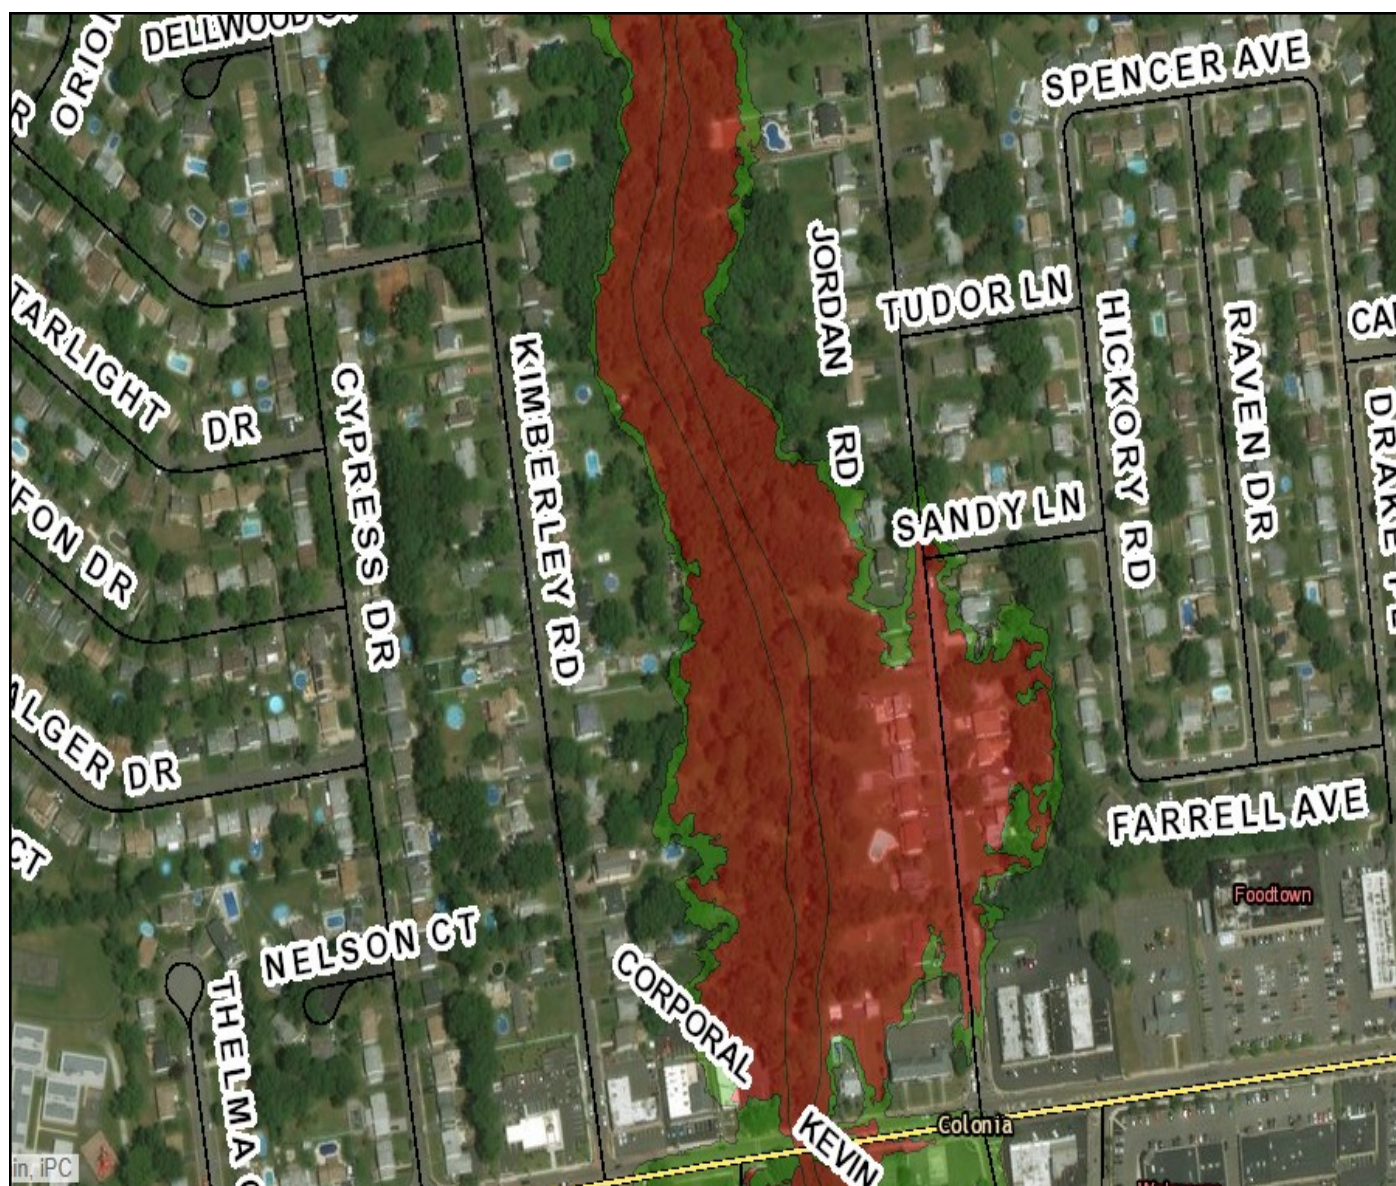
Figure 21: Neighborhood vulnerable to fluvial flooding along Pumpkin Patch Brook near Jordan Road (2010 FIRM SFHA, as displayed on Woodbridge Township GIS)

To the north west, riverine flooding also occurs in non-tidal Category two stream known as **Pumpkin Patch Brook** which flows northerly towards the Township of Clark (Figure 21) . Pumpkin Patch Brook discharges to the Robinsons Branch of the Rahway River, and suffers similar drainage issues in regards to receiving high volumes of surface water run-off from impervious sub-urban development. For example, overbank flooding associated with the aforementioned water body has caused localized damage concerns in the Jordan Road neighborhood. Within this neighborhood (just upstream of the Inman Avenue crossing) the estimated ground elevation is 66.5 ft NAVD. Further, some flood-prone structures in this neighborhood possess basements and therefore are at an increased risk to receive flood damage, as the FEMA delineated 100 year flood elevation at this location is 66 ft. NAVD.
